St Barbara Mining engaged Goldfields Protective Coatings (GPC) to undertake the complete protective coating refurbishment of its gold processing Cyclone Tower. Scope of work included all structural steel columns, supports, braces, stairways, landings and handrails.

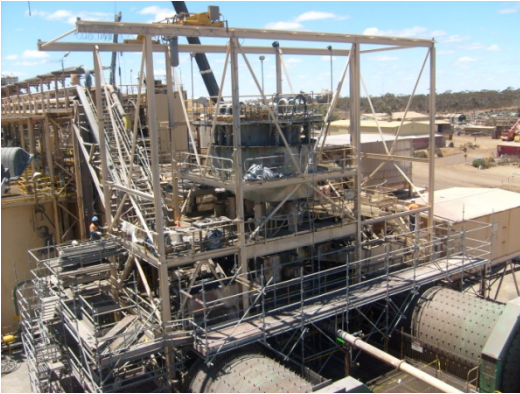
- Completed refurbishment of Cyclone Tower structural steel.
- Scaffolding with shade cloth (dust & overspray control) and Independent stairway.
- Detail photo of completed structural steel refurbishment.

All structural steel surface areas were prepared by abrasive blast with inspection and subsequent mechanical repairs carried out. A customised protective coating system, designed and implemented by GPC, incorporated increased film build in wet areas to ensure substrate protection and increase time to next maintenance.
