Goldfields Protective Coatings (GPC) was engaged by St Barbara Mining for the internal refurbishment of all eight carbon-in-leach (CIL) gold processing tanks at their Gwalia operations.

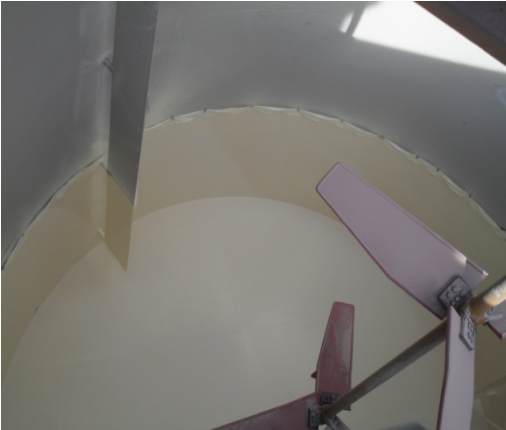
- Polibrid 705E applied to bottom strake of CIL tank.
- Surface preparation by abrasive blast.
- Specialist application of Polibrid 705E with wet film testing

GPC undertook tank internal abrasive blasting to allow full inspection and any required substrate rectification works. Post mechanical repairs, the surface was prepared for protective coating application. Upon achievement of surface contamination and profile requirements, GPC applied Polibrid 705E (elastomeric urethane) to internal surface areas including walls, floor and baffle plates.
